Cahora Bassa HVDC line emergency restoration

by Mike Rycroft, features editor, EE Publishers

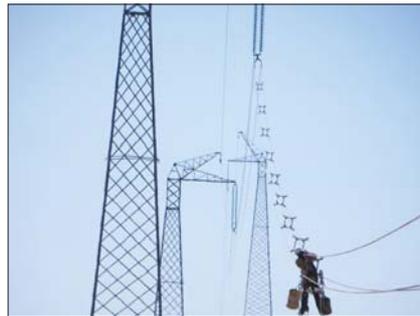
Fig. 2: Fitting spacers on the new section.

Even though one less conductor results in less wind-loading, vibration had to be taken into account here, especially in the long unprotected span. It was therefore decided to over-damp the line by putting fitted spacers every 30 to 50 m along the span. It was also necessary to install armour-rods to protect the ACCC conductor where the spacers were installed.

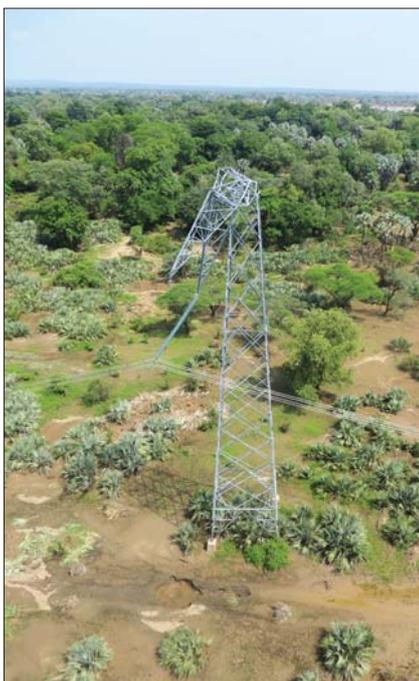
Fig. 1: Damaged towers which had to be repaired.

The total project duration was about seven weeks from NOA (notification of acceptance) to handover. Some of the existing structures had to be strengthened before the stringing of the new conductor. Two towers had to be repaired by replacing critical sections. Due to the tight time constraints, only two weeks were available for preparation, mobilisation and permitting. Bulldozers had to be hired to make roads to gain access to site line. Theft was a concern and the sites had to be fenced off with 24 hour security.❖

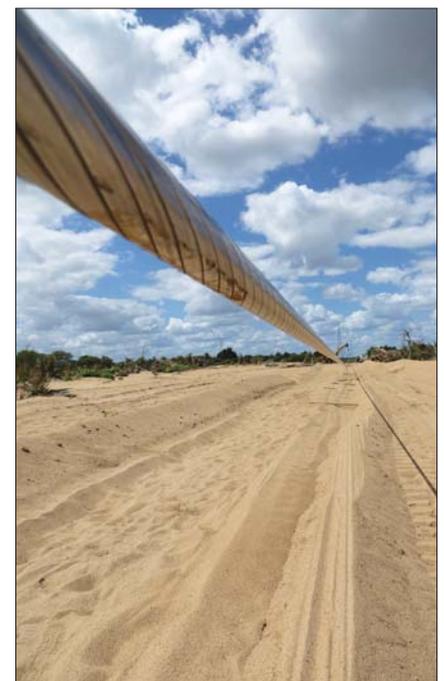
Fig. 3: ACCC Lisbon conductor was used in the repair of the section.

The line was restored using the Aluminium Composite Core Conductor (ACCC) conductors from CTC/ARB to replace the damaged 5,3 km section. This conductor consists of a composite core technology allowing for the use at high mechanical and electrical loading and the low resistance aluminium stranding reduces the line losses. This allowed the team to cross the 812 m section.

that a 3 bundle ACCC Lisbon conductor (315,5 mm²) would suffice, taking corona into account. Tests on the conductor were done at the CSIR which yielded a breaking strength of 109 kN.

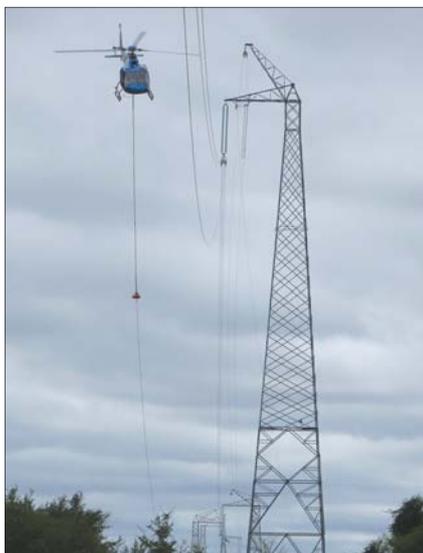
Fig. 6: Helicopters were used extensively for transport and other purposes.

The client supplied the insulators, hardware and replacement towers, which had to be transported from Chamoy in Mozambique. The rain and floods washed away some of the access roads, which meant the trucks could not reach the site. QSA had to establish a secure off-loading area, about 20 km away and everything had to be air lifted by helicopters. Two helicopters were on site for the duration of the project.

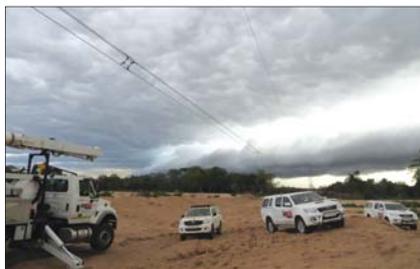
Fig. 7: The 812 m span.

The biggest engineering challenge was the 812 m span. The flooding and the time constraints on the project made it impossible to construct a new tower. The use of any conductor over that span length resulted in an increase of mechanical loading on the existing structures, which had to be reinforced.

The ACCC being lighter than the conventional conductor per sq mm was another benefit as it allowed the contractor, in this case, to reach the required clearances under the allowable tower loadings. The 5,3 km section of the route was strung under higher than normal tensions than the rest of the route, and it was necessary to counter stay the strain towers at either both ends.
